EARTH DISTURBANCE INSPECTION REPORT

Project Name PA Pipeline Project (SUNOCO) **Inspection Date** 10/13/17 **Inspection Time** Approx 1:00 PM
Weather Conditions overcast approx 60° F, Approx 1.6 inches rain past 48 hours **Total Project Area** approx. 223 ac
Location East/west through county **Total Disturbed Area** approx. 223 ac
Municipality South Londonderry Township **County** Lebanon
Receiving Water(s) Killinger Creek **Designated/Existing Use** TSF

Date:	10/13/2017	Site Name:	PA Pipeline Project (SUNOCO)	Permit #	ESG03000015002
Muni:	S Londonderry twp	Inspection #	SUN 019	District #	38-910-004-15
WEATHER:	during inspection:	overcast, temp approx. 60° F		Photographer:	KK
WEATHER	Prior 48 hrs:	Approximately 1.6" rainfall		Camera Type:	Canon Digital 1300

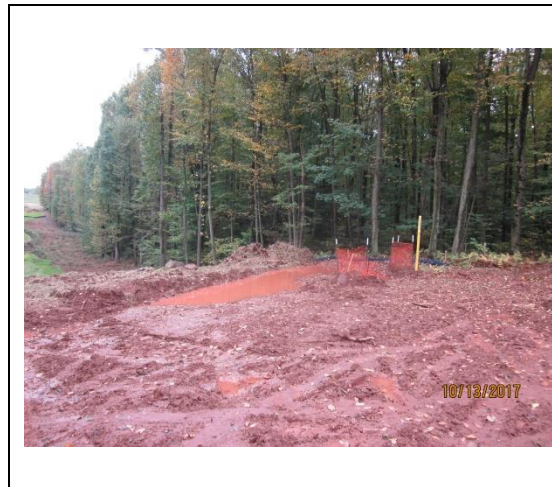
Water bar and sock filter/sump west of crossing S-A3 in area west of beech street .

1. Continue to maintain waterbars and rce's as per plan.
2. As per regulation, upon temporary cessation of an earth disturbance activity or any stage or phase of an activity where a cessation of earth disturbance activities will exceed four days, the site shall be immediately seeded, mulched, or otherwise protected from accelerated erosion and sedimentation pending future earth disturbance activities.
3. Lccd suggests installing a sediment control device in the area referenced in site description and observation 3. Exact location discussed with environmental inspector.
4. Maintain erosion control devices to minimize the potential for accelerated erosion and sedimentation.

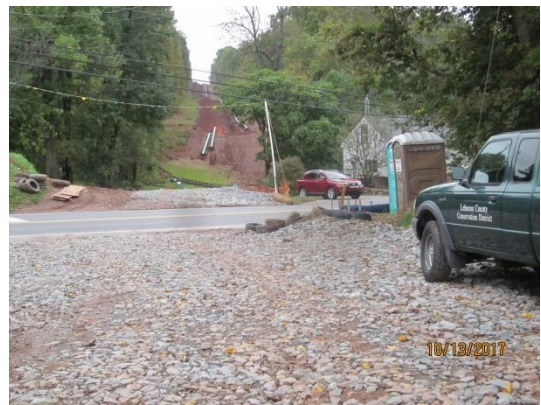
View of rce's looking west across SR 0117.

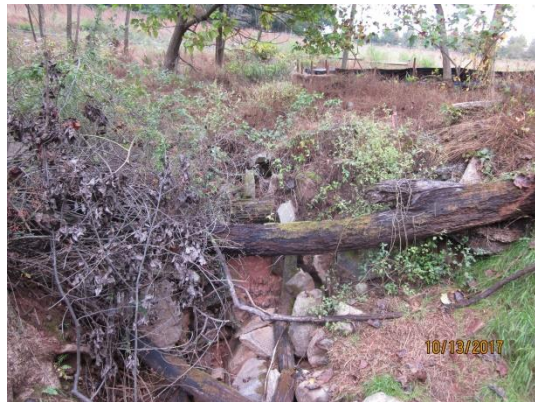
View from timber bridge (S-A1) looking upstream. Sediment deposition in debris pile near bottom center of photo and in area of silt fence and straw bales in upper right portion of photo.

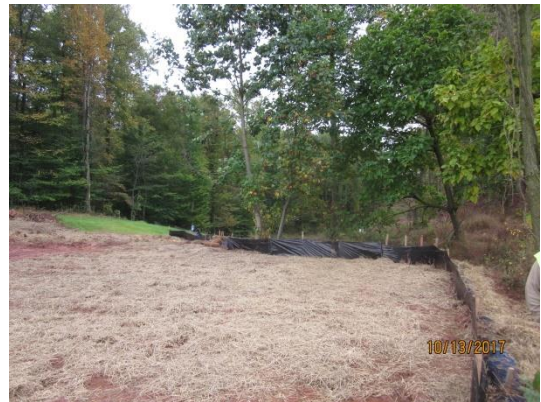
Back toward beech street. View downstream toward first timber bridge (S-A1). Suggest installation of sediment trapping facility in area of outside corner of silt fence.

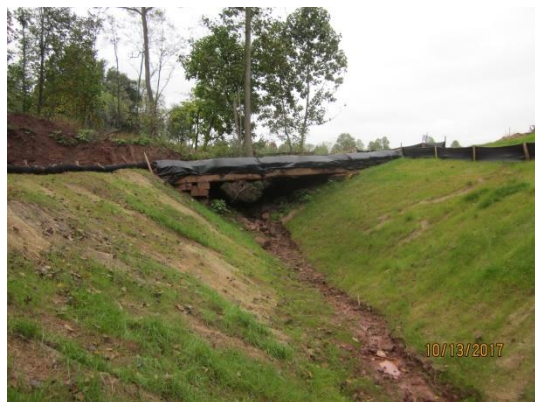
View looking upstream (S-A1) under first timber bridge west of beech street.

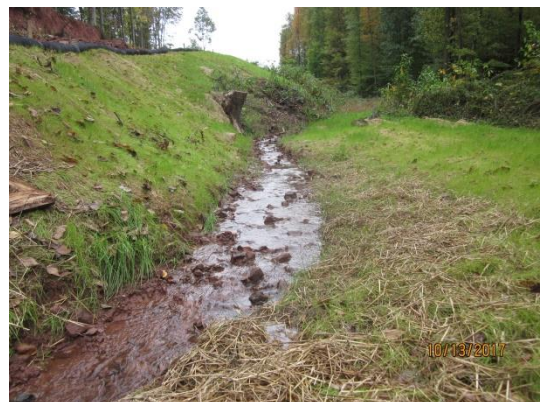
Killinger Creek running clear. Shot facing east looking upstream from crossing S -A2.
